Notice of Public Meeting of the Design and Historic Review Commission of the City of Yuma

Design and Historic Review Commission Agenda

This is a request by C. Kevin Eatherly, on behalf of Ron Pailliotet, to demolish the Drake Hotel, located at 29-39 W. 2nd street, in the Brinley Avenue Zoning District.

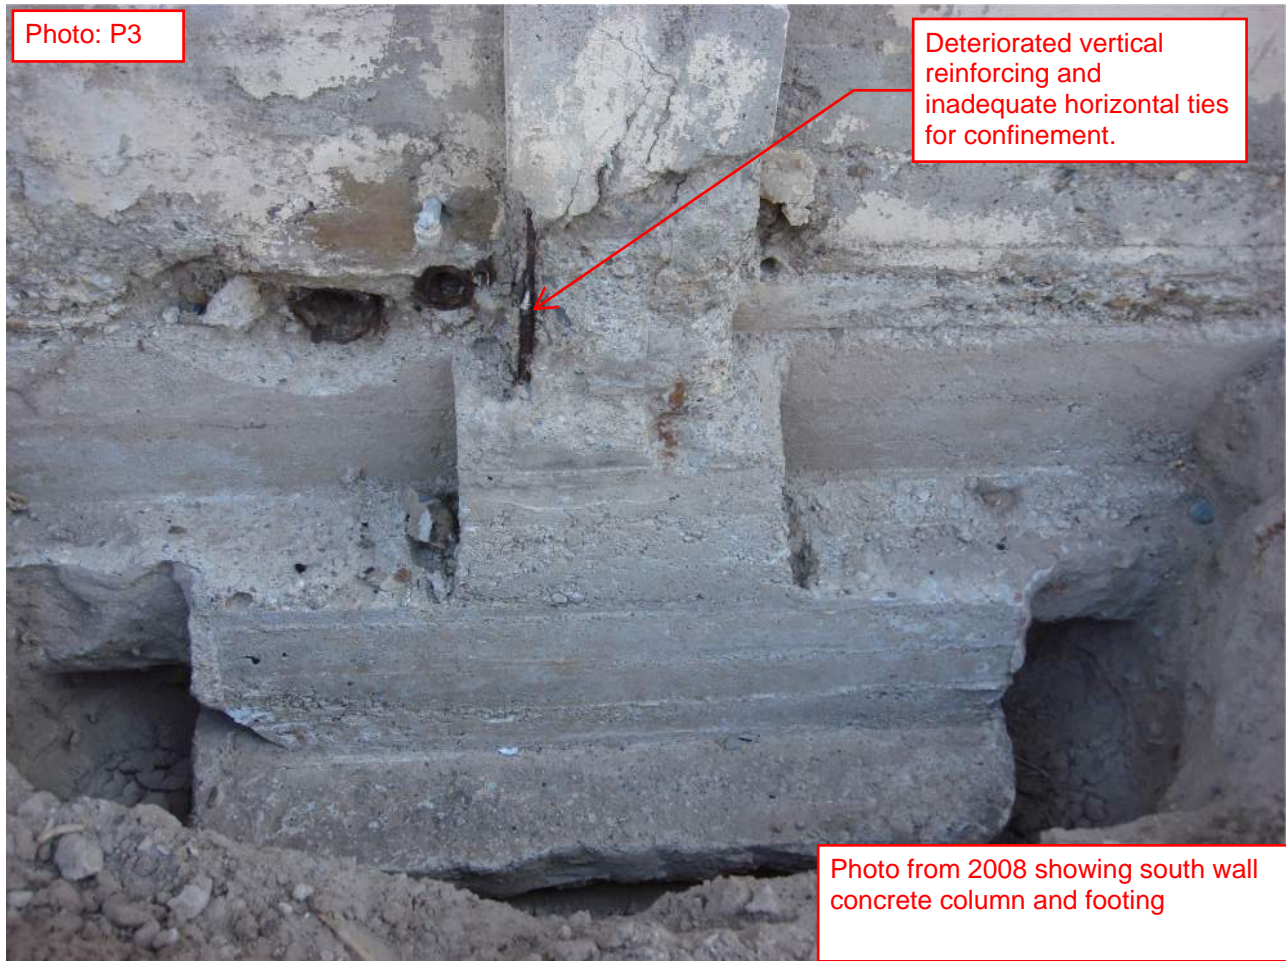
Photo: P3

Photo from 2008 showing south wall concrete column and footing

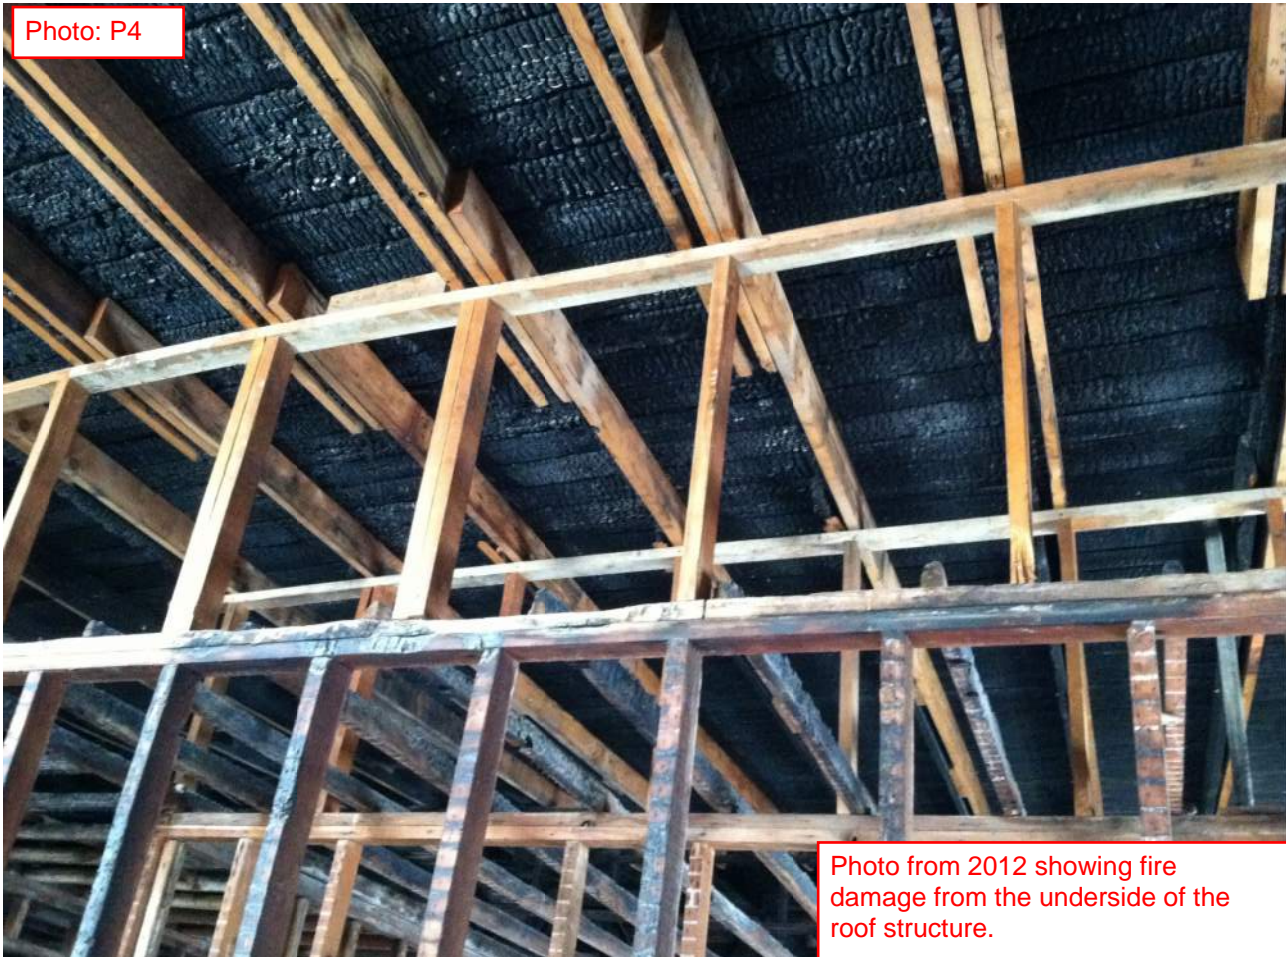
Photo: P4

Photo from 2012 showing fire damage from the underside of the roof structure.

The current condition of the Drake Building requires structural strengthening, at a minimum, to 100% of the roof members due to fire damage and deficient capacity for the 14ft. joist spans. This level of work is defined as a substantial structural alteration according to the 2018 IEBC. Alteration level 3 with substantial structural alterations require the following structural strengthening:

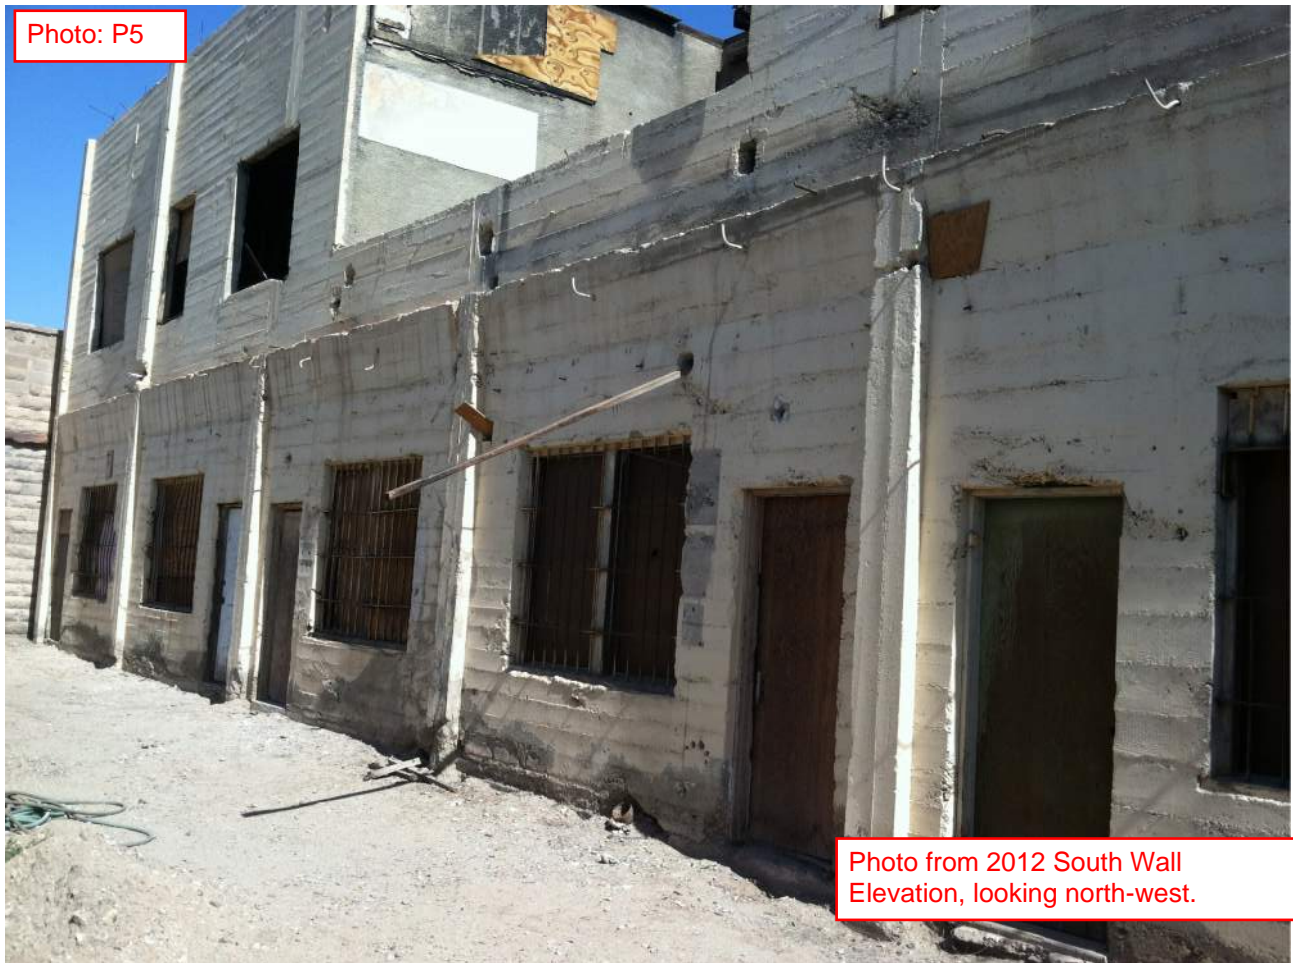
Photo: P5

Photo from 2012 South Wall Elevation, looking north-west.

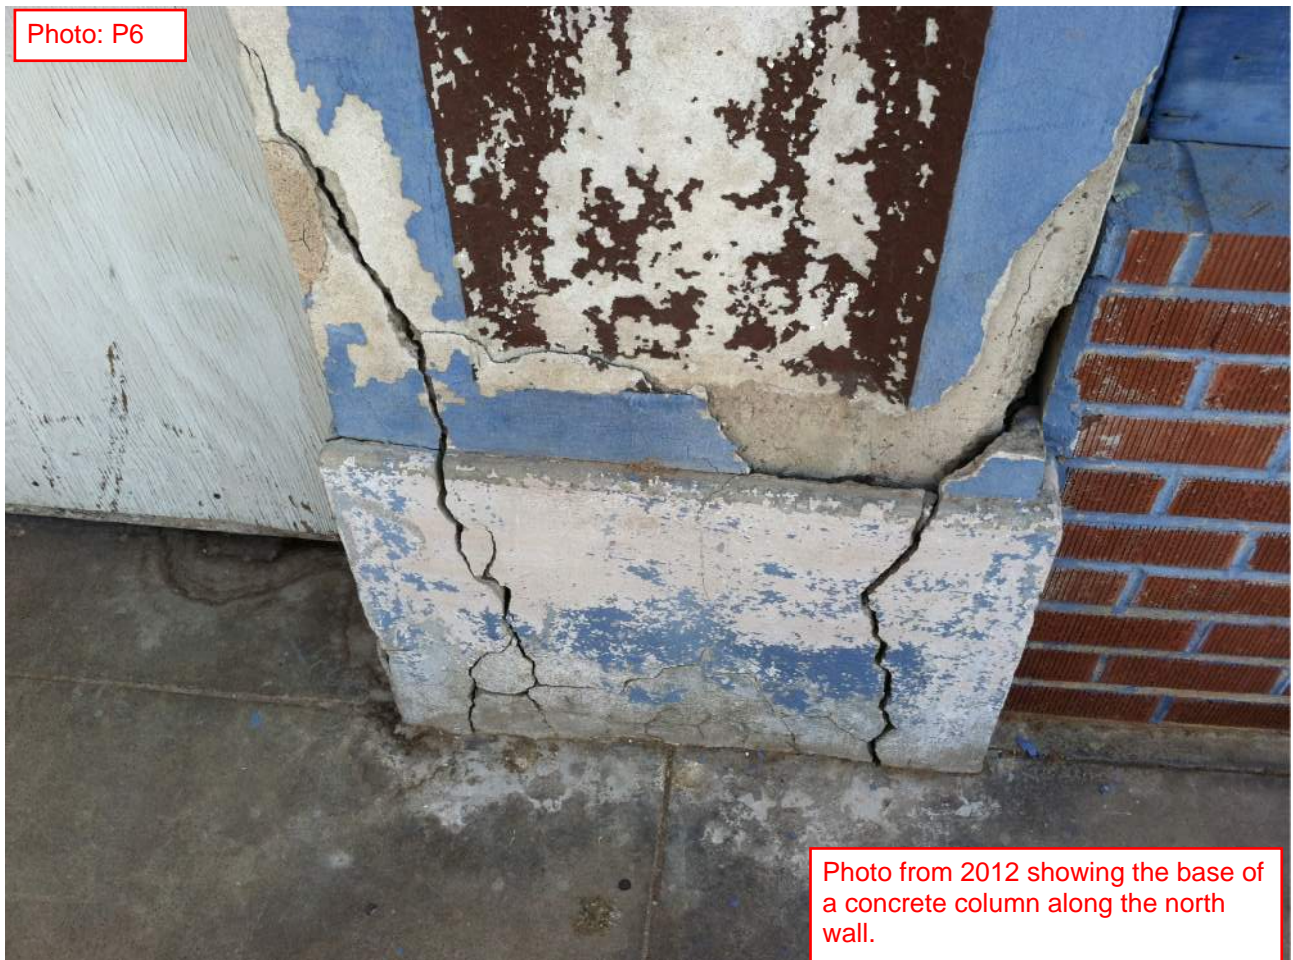
Photo: P6

Photo from 2012 showing the base of a concrete column along the north wall.

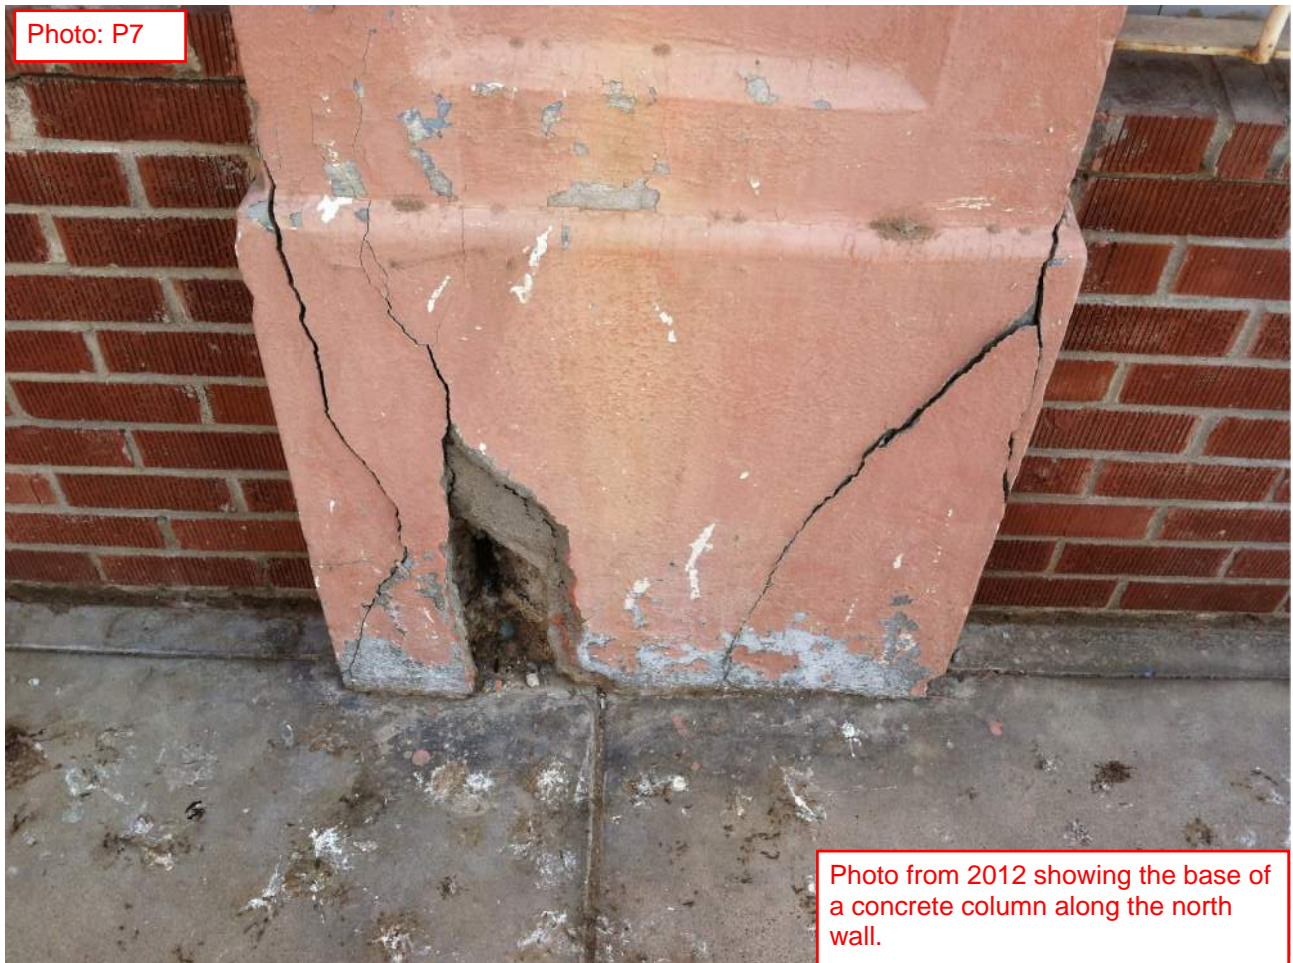
Photo: P7

Photo from 2012 showing the base of a concrete column along the north wall.

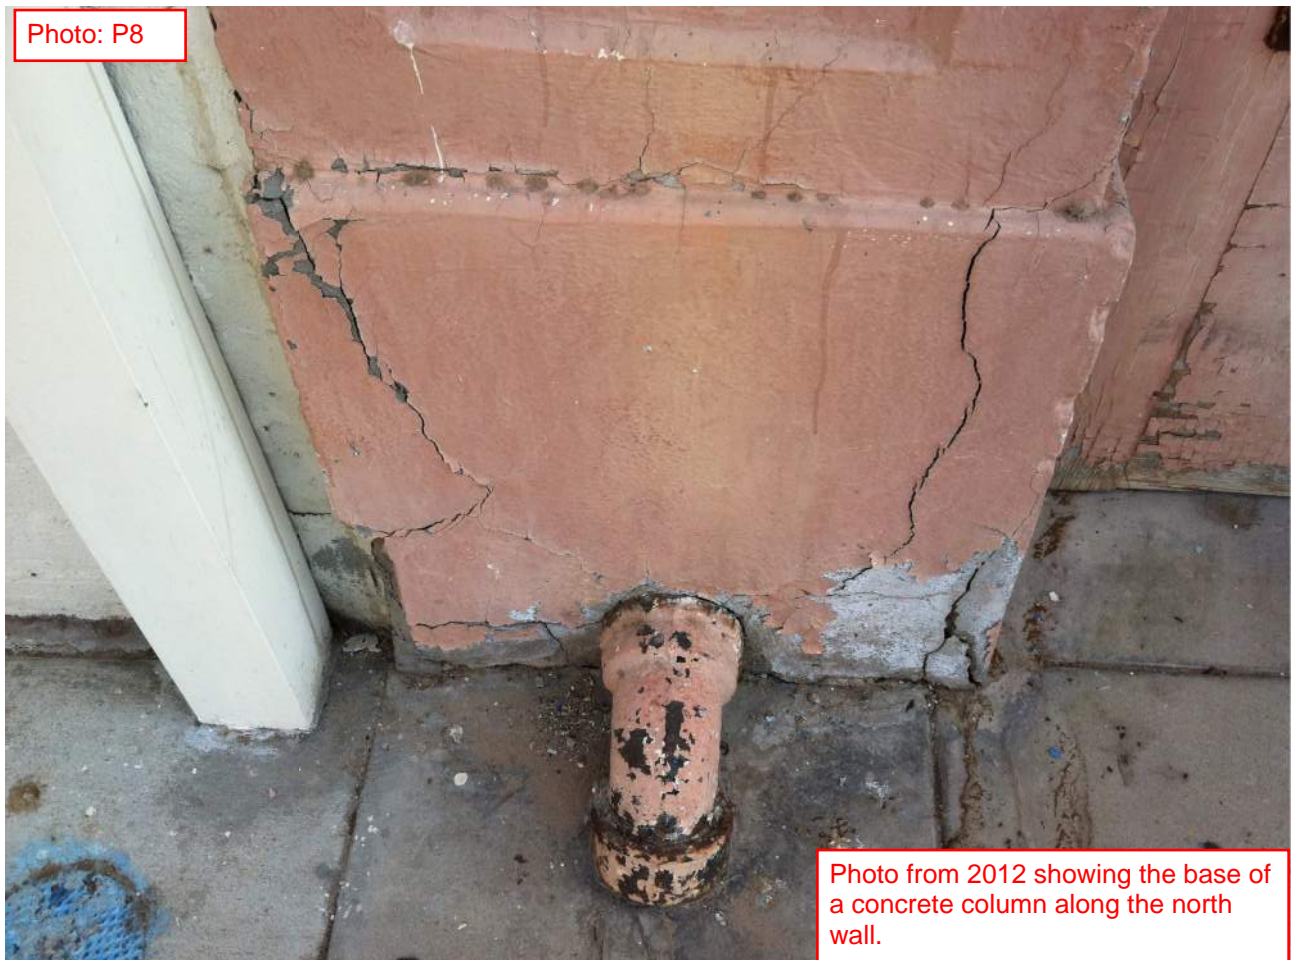
Photo: P8

Photo from 2012 showing the base of a concrete column along the north wall.

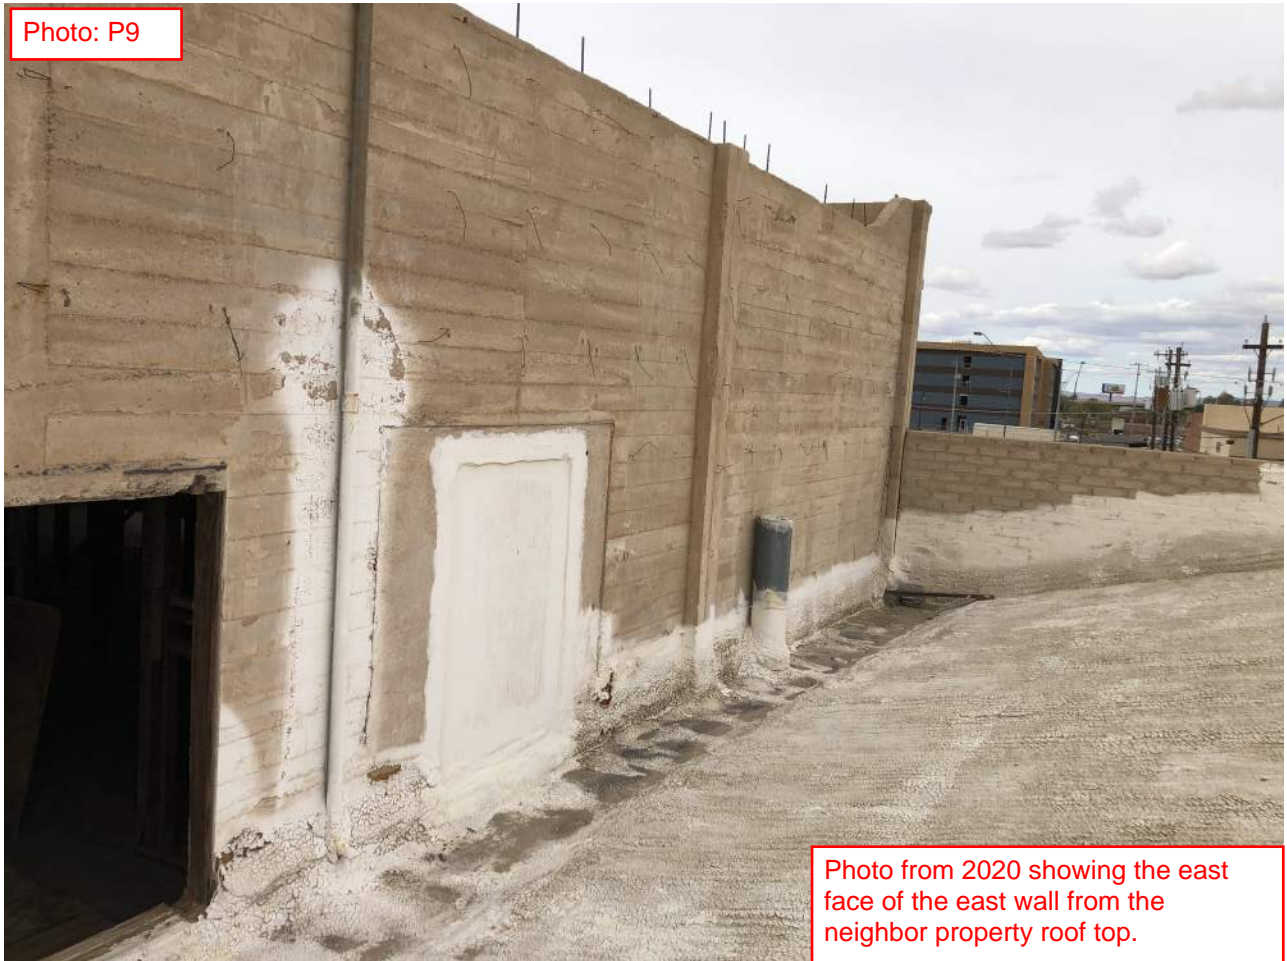
Photo: P9

Photo from 2020 showing the east face of the east wall from the neighbor property roof top.

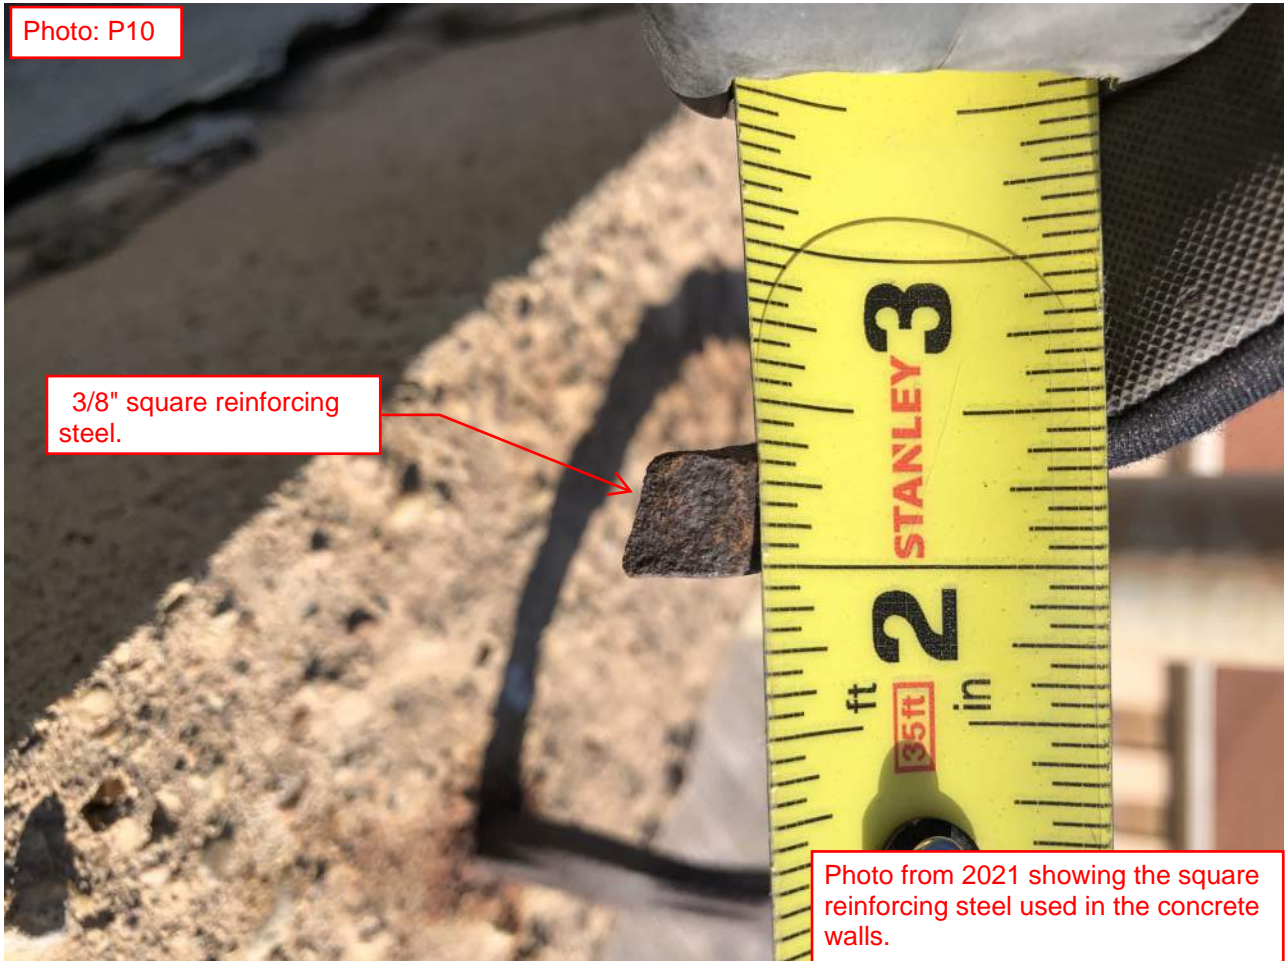
Photo: P10

3/8" square reinforcing steel.

Photo from 2021 showing the square reinforcing steel used in the concrete walls.

- The existing concrete walls are under-reinforced, in poor condition, have a low compressive strength and do not meet the code required minimum area of reinforcing steel.
- The existing concrete beam stress cracks require strengthening or replacement.
- The cracked concrete walls require strengthening or replacement.
- Concrete columns require additional confinement reinforcing or replacement.
- Unreinforced brick masonry walls require strengthening or removal.
- Concrete walls require positive anchorage to the roof diaphragm and floor diaphragm.
- Roof structure requires strengthening along with the addition of plywood and diaphragm cross ties.
- Floor structure requires the addition of plywood and diaphragm cross ties.

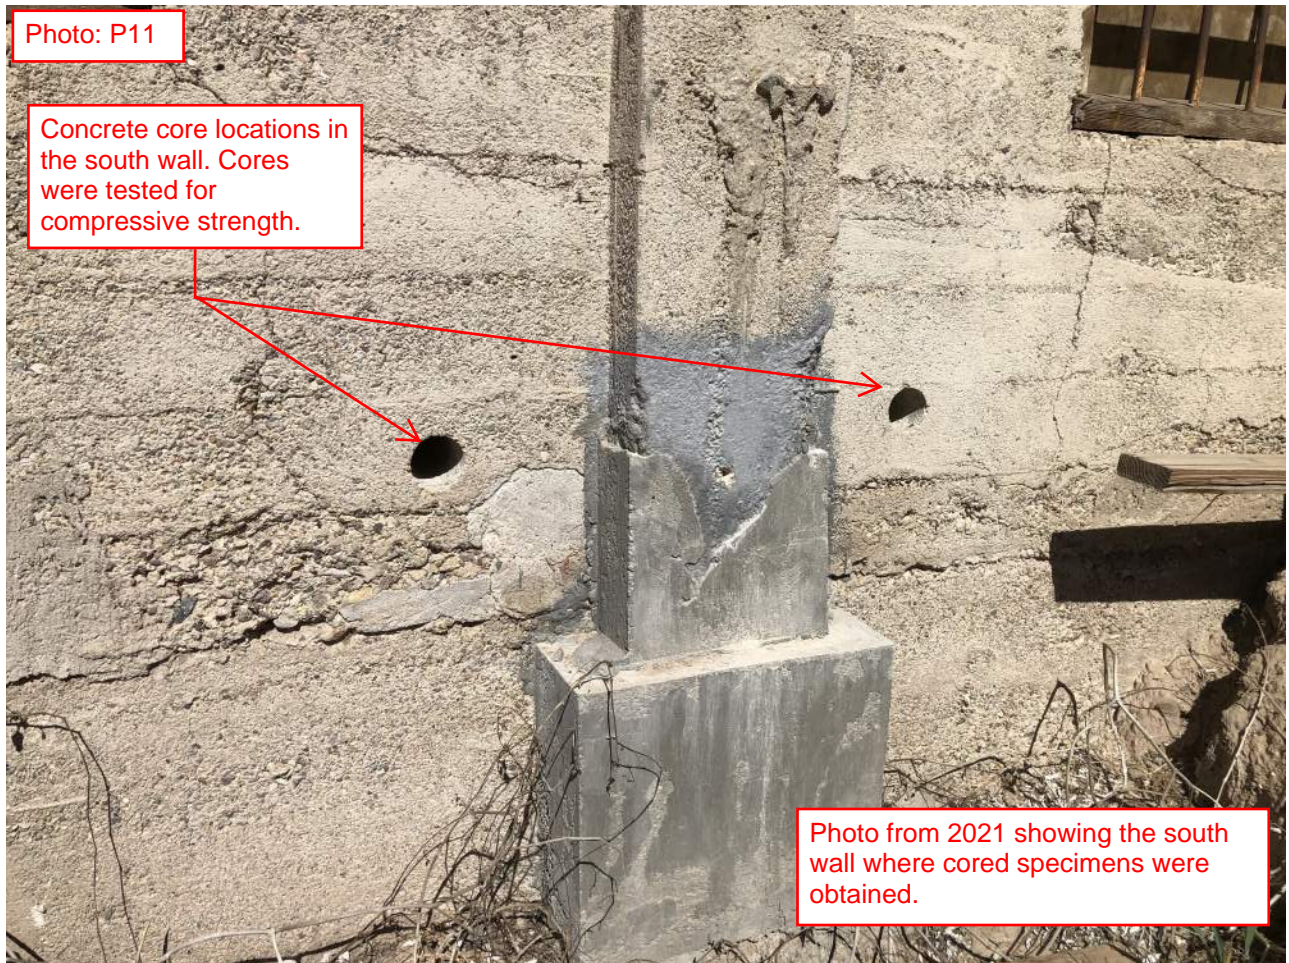
Photo: P11

Concrete core locations in the south wall. Cores were tested for compressive strength.

Photo from 2021 showing the south wall where cored specimens were obtained.

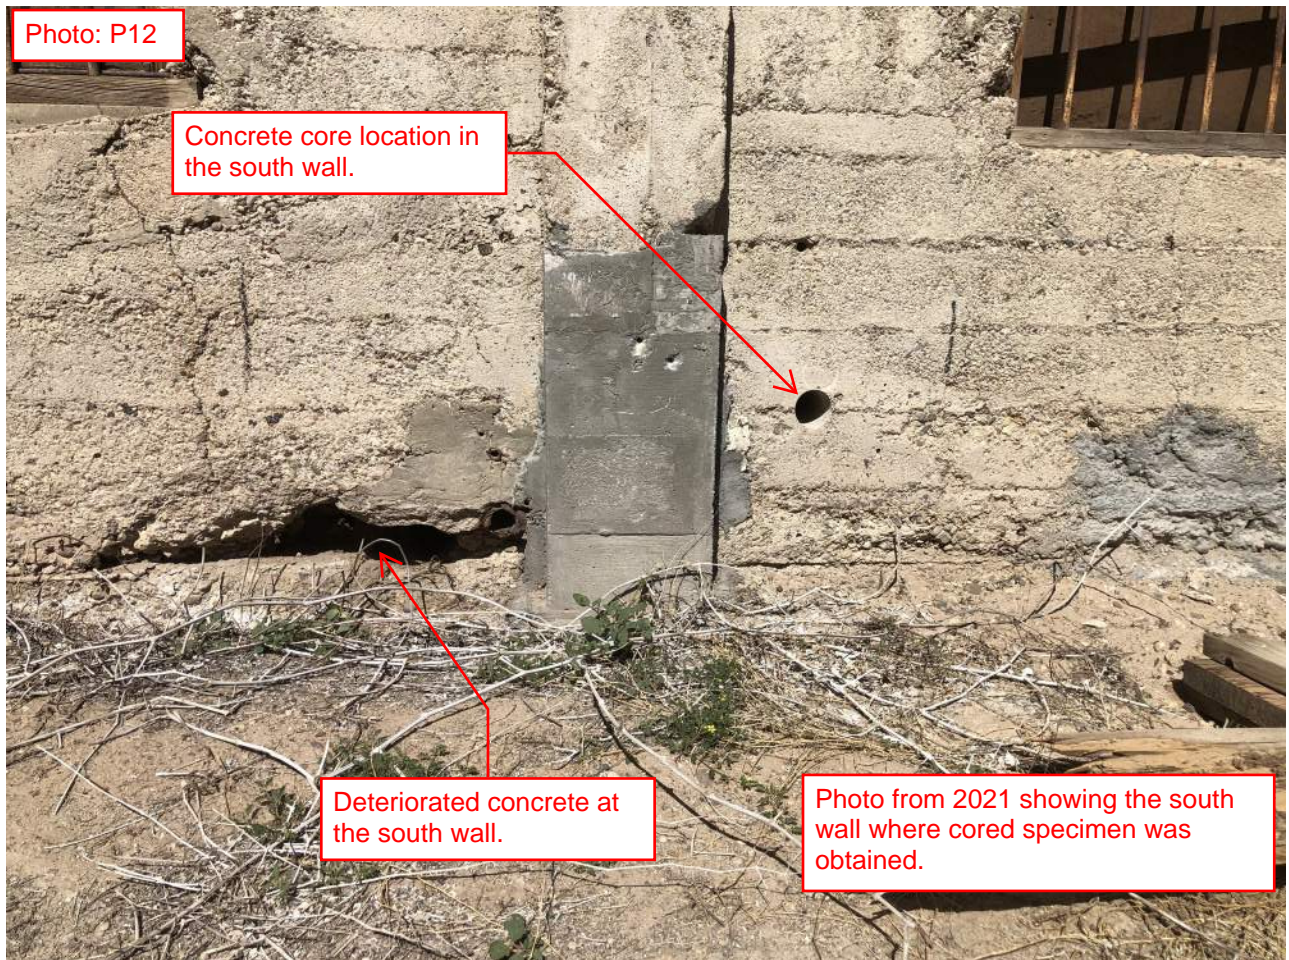
Photo: P12

Concrete core location in the south wall.

Deteriorated concrete at the south wall.

Photo from 2021 showing the south wall where cored specimen was obtained.

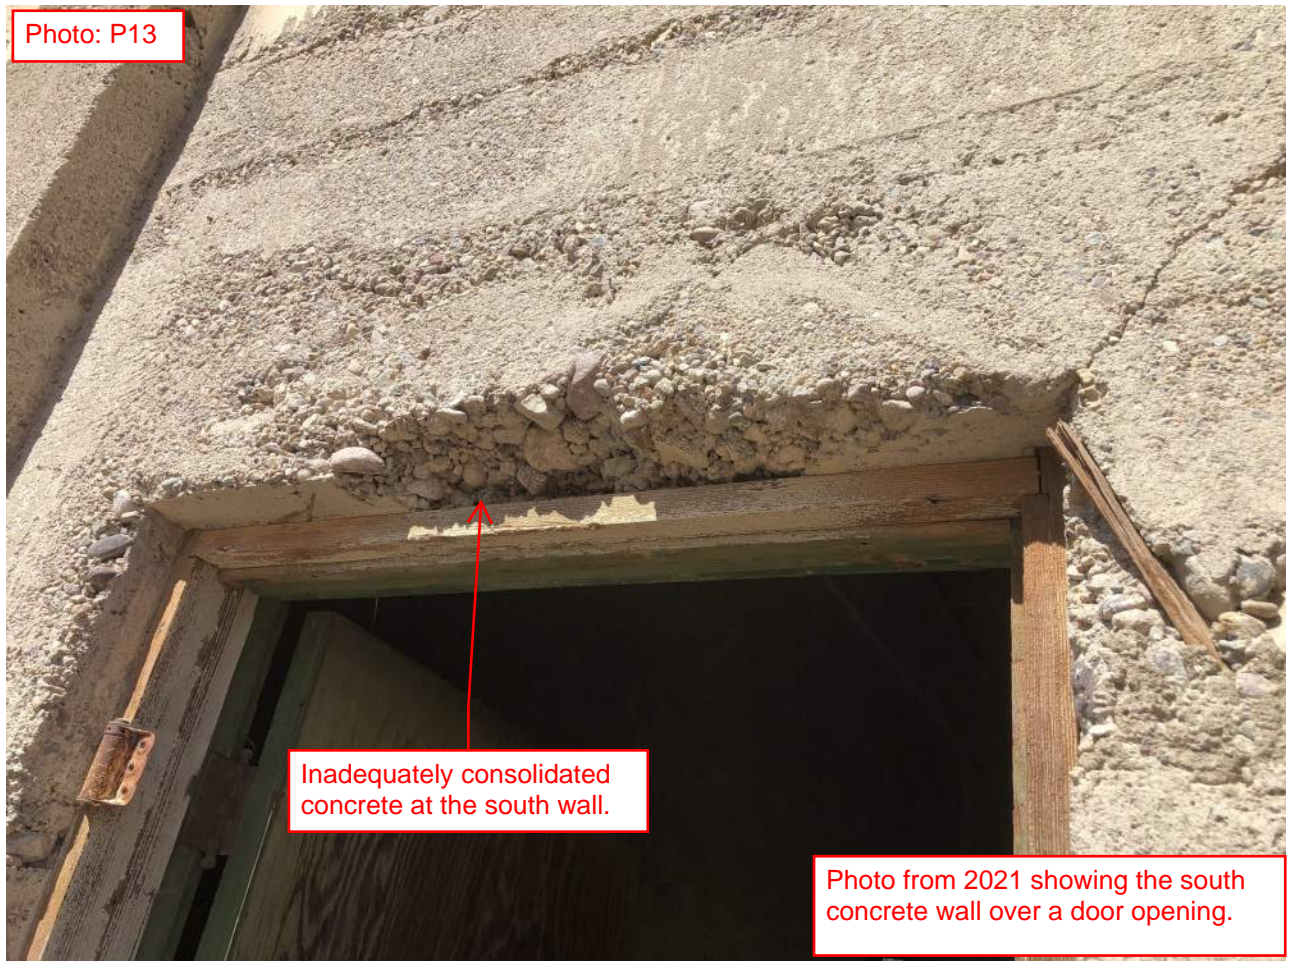
Photo: P13

Inadequately consolidated concrete at the south wall.

Photo from 2021 showing the south concrete wall over a door opening.

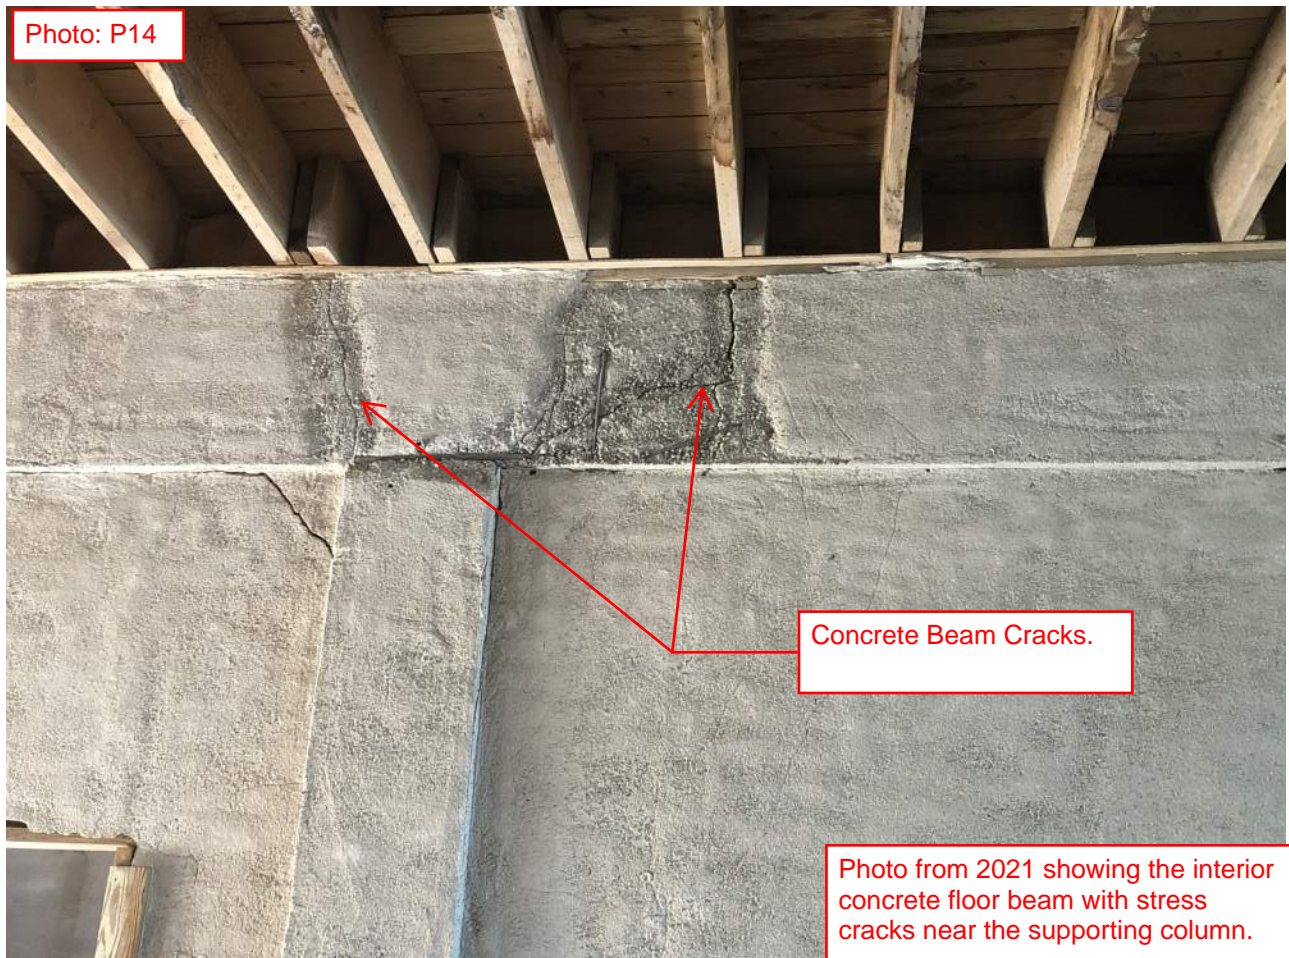
Photo: P14

Concrete Beam Cracks.

Photo from 2021 showing the interior concrete floor beam with stress cracks near the supporting column.

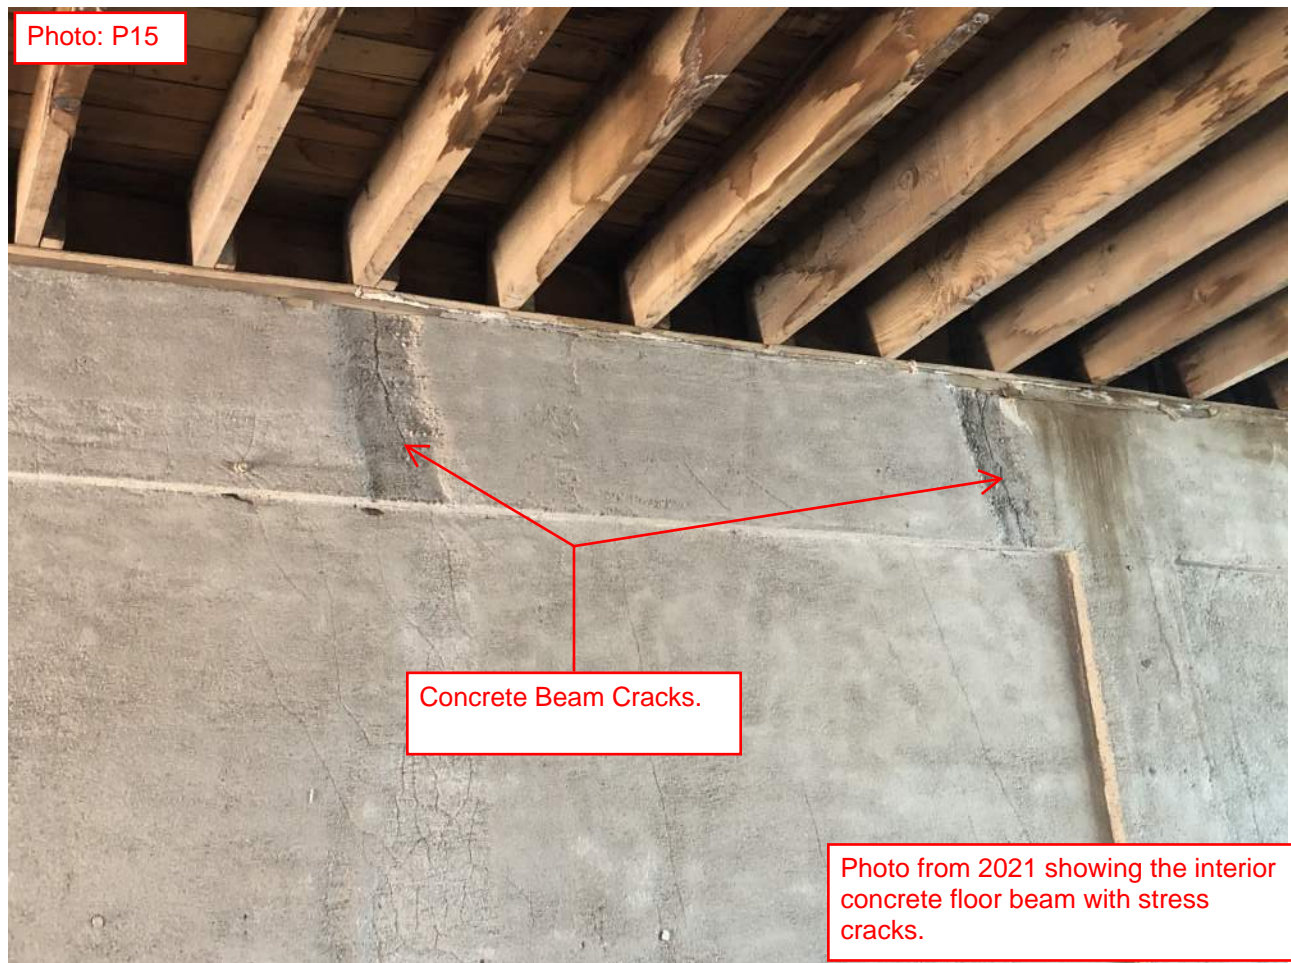
Photo: P15

Concrete Beam Cracks.

Photo from 2021 showing the interior concrete floor beam with stress cracks.

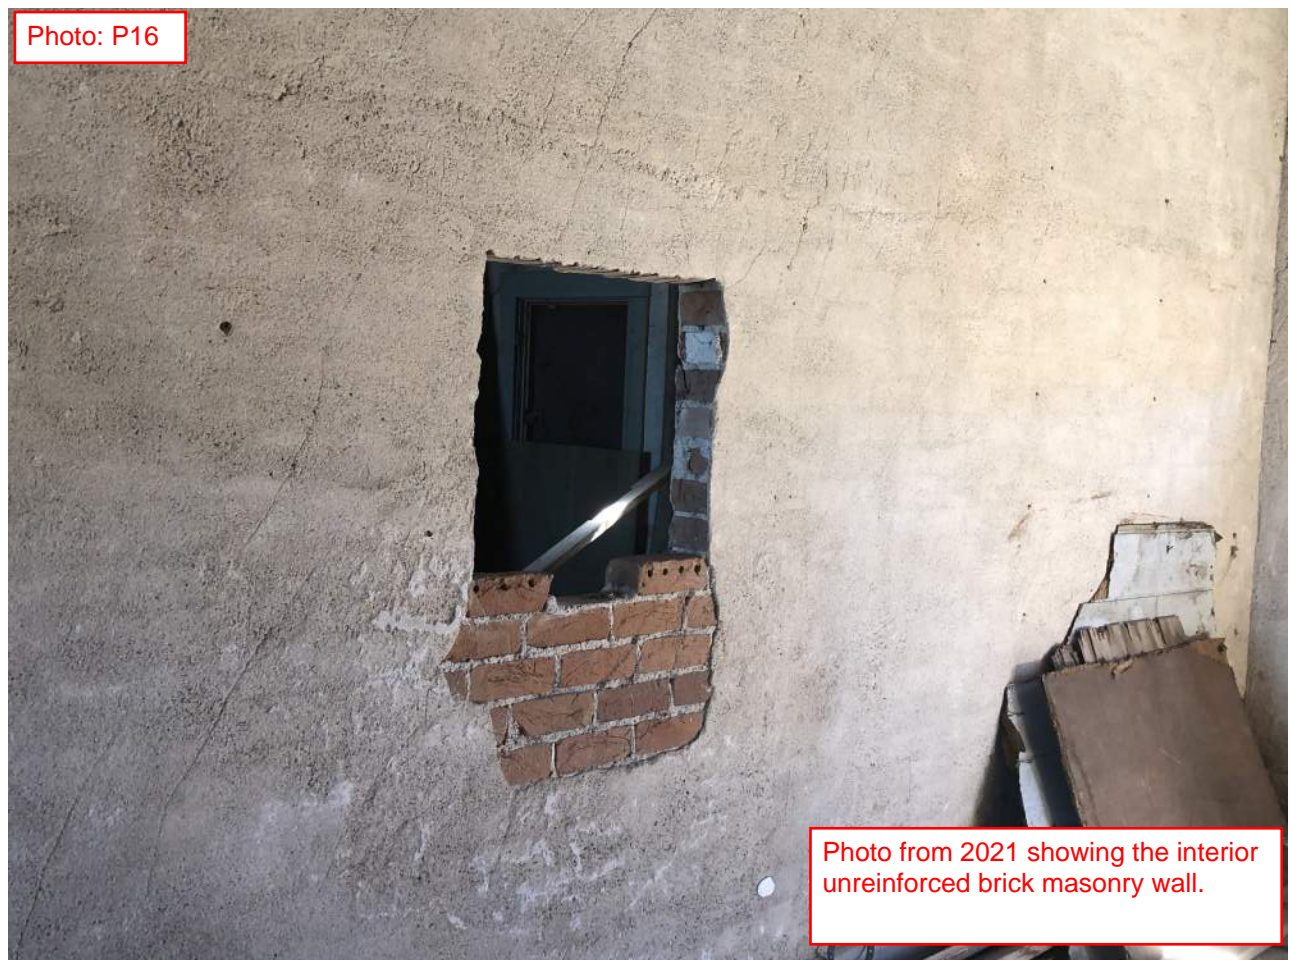
Photo: P16

Photo from 2021 showing the interior unreinforced brick masonry wall.

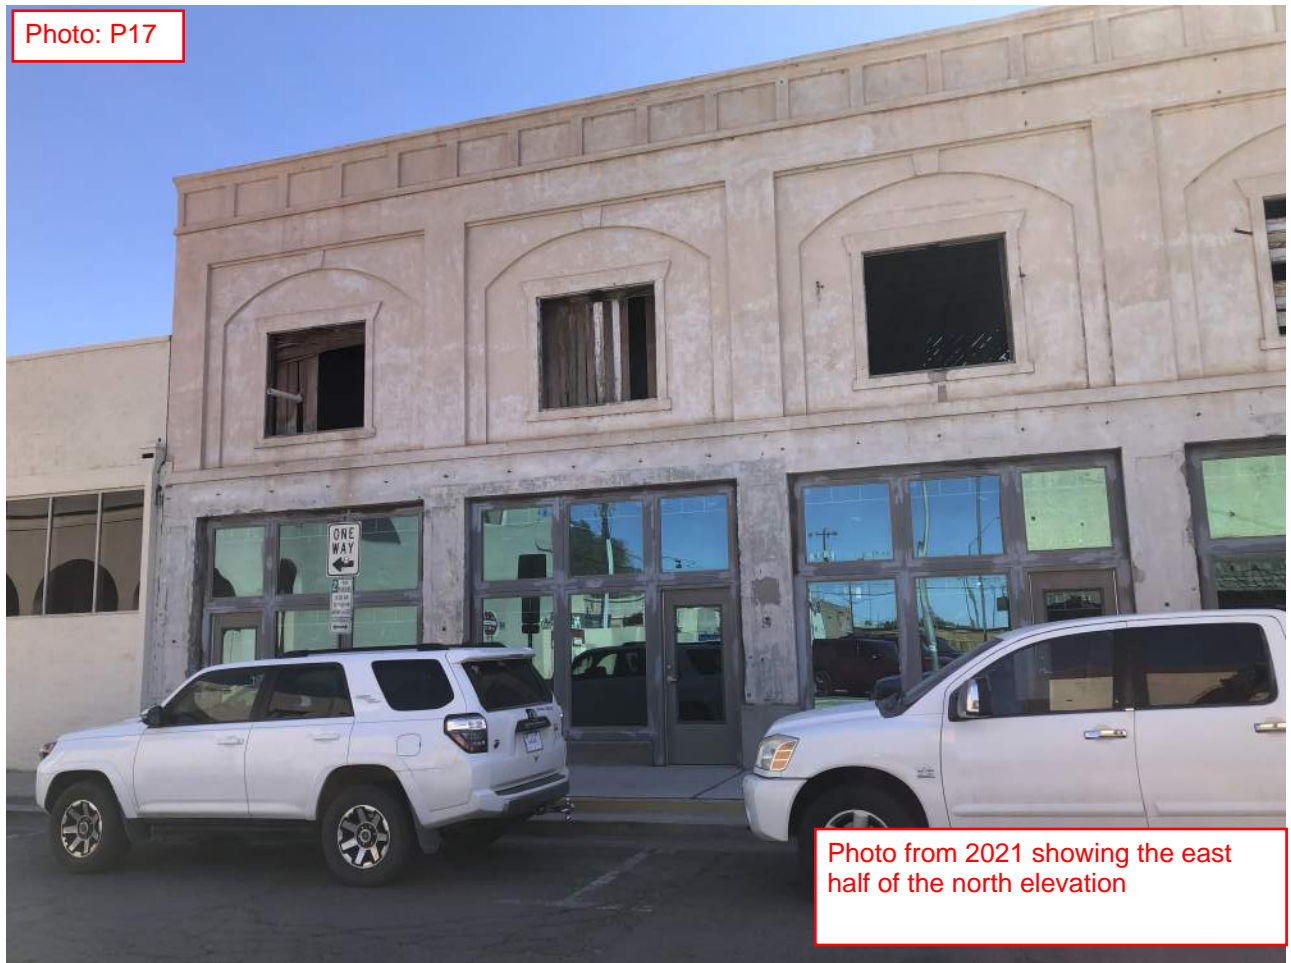
Photo: P17

Photo from 2021 showing the east half of the north elevation

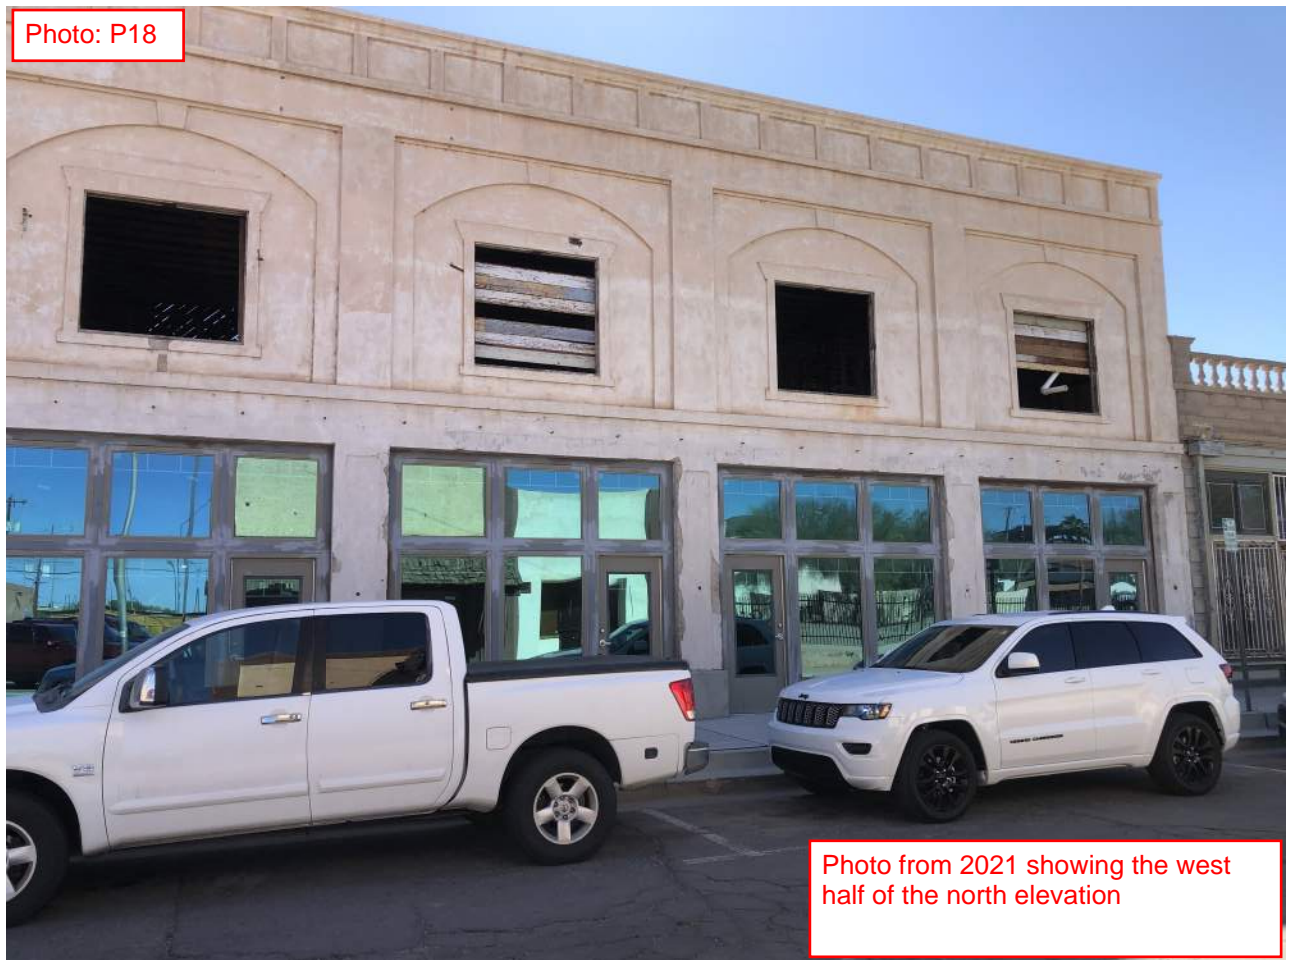
Photo: P18

Photo from 2021 showing the west half of the north elevation
